Boat Inspection Report: Vessel ""

Report No: 100000010

Make: Alpa 42 Long Keel Ketch
Type: Offshore Cruiser.
Advised Build Date: 1977
Builder: Alpa yachts, Italy
Designer: Sparkman and Stevens
Hull Number: 43
SSR No 111804

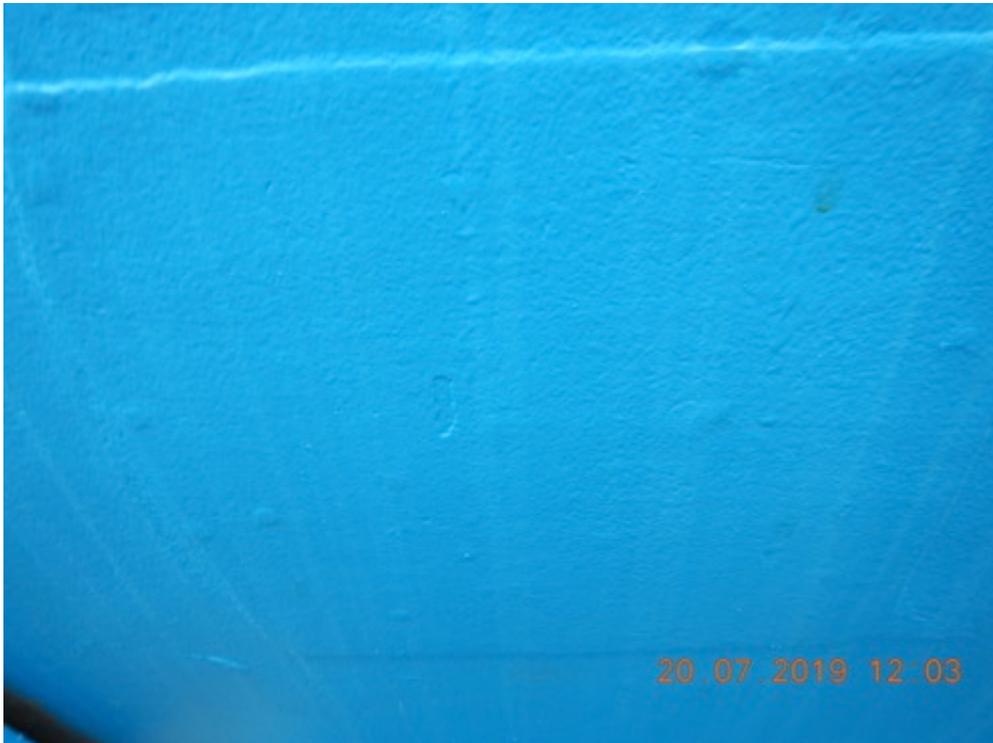
When first surveyed the vessel it was found to have considerable blistering over the underbody. He believed that the blistering was in the outer coating only and not an osmosis problem. After purchase he had the underbody soda blasted which confirmed that the original clear gel coat was not damaged and the moisture content was not a cause for concern. Moisture content in the underbody was between 10 and 24 in deep reading mode on a sovereign moisture meter. This can be considered good.

There were six patches of the original coating left where support pads had been when the vessel was soda blasted. These patches had much higher moisture content up to 30 confirming that all the moisture and blistering was in the outer coating.

Outer coating not blasted off where the support pads were.

Suggest: Sand off the balance of the outer coating.

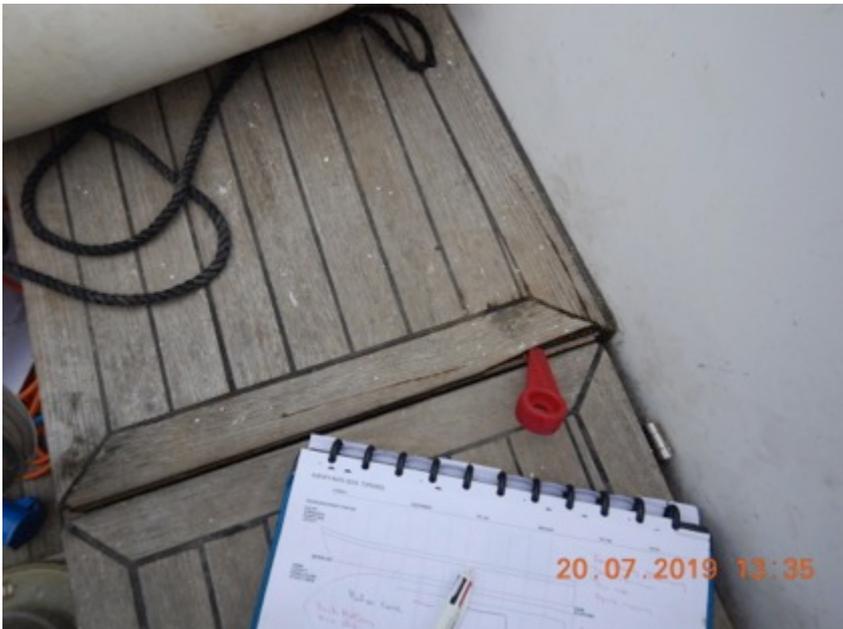
There was some damage to the aft port locker lid which was badly rotten but this was not considered serious as there was glassfibre below.

Suggest: Replace the teak decking in the cockpit which has become rotten.

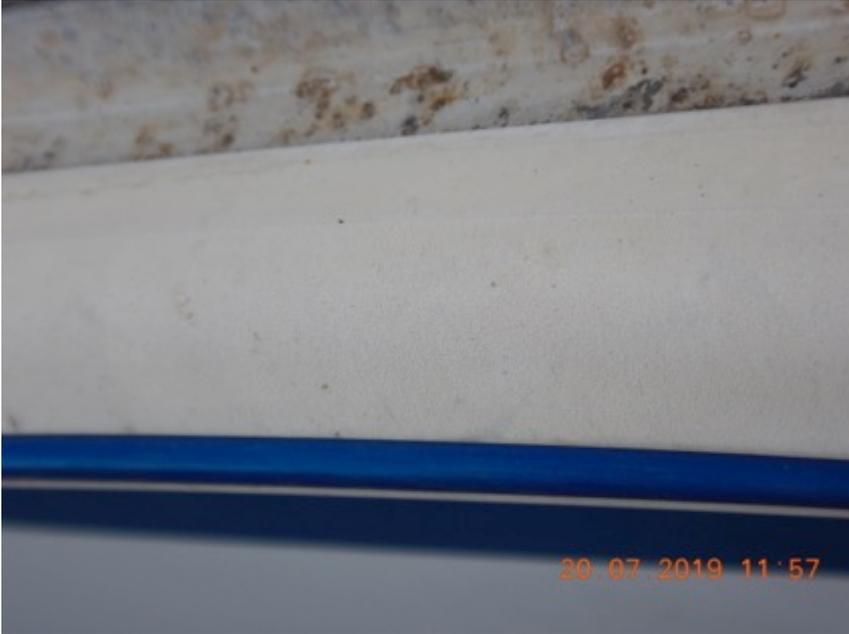
The hull deck joint was of an external overlap bonded construction, mechanically fastened with an aluminium rail to which the rubber buffer was attached. The hull deck joint cover was different on each side of the boat. Although the existing are visually serviceable the rubber buffers have been screwed to aluminium with stainless steel self tappers and are beginning to corrode their way out of the aluminium strip. We were advised this arrangement was to be replaced.

Recommend: Replace the hull deck joint cover in the next few months.

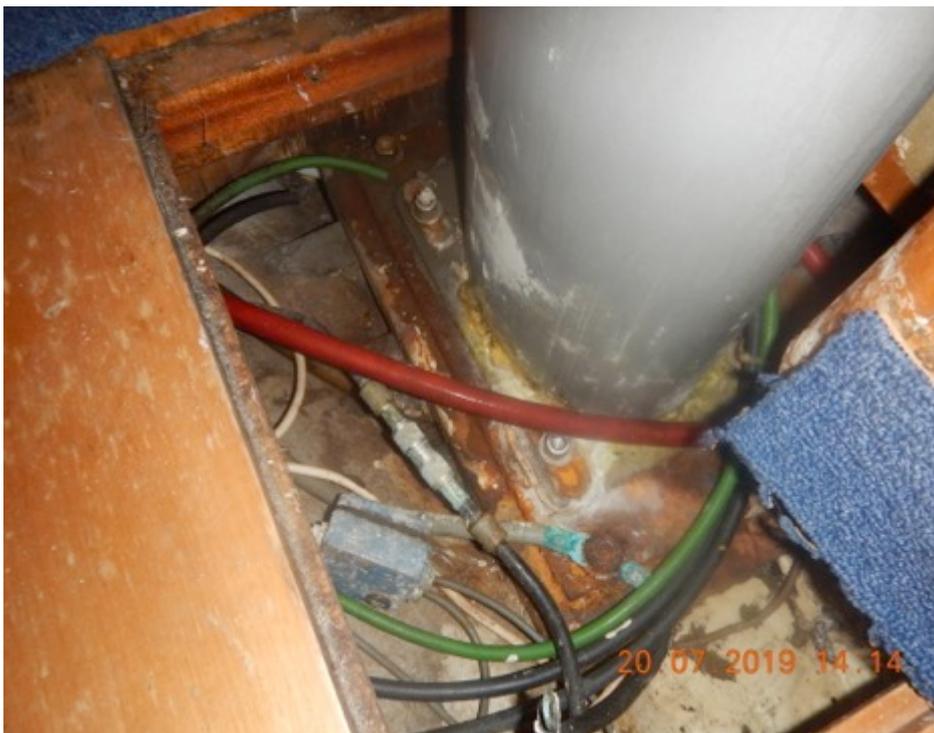
The single spreader keel stepped main and mizzen masts were silver anodised and was in fair visual condition. The masts were sighted from behind and were noticeably out of line. The mizzen mast was visibly out of line where it came out through the deck collar.

The masts were stepped on steel plates and on to substantial oak blocks. Unfortunately in this area the bilges were not properly limbered so there was heavy corrosion to the steel plates and some rot was found to a loose plywood partition. It was agreed with the owner that when the masts were unstepped to transport the vessel the minor corrosion problems with both mast steps would be resolved

Recommend: Within 12 months unstep both masts, remove and clean both steel pads, remove any rotten timber and limber the bilges correctly to stop this problem re occurring.
