## Boat Inspection Report

Report No: 1001

Make: Maxum  
Type: 2700 SE  
Advised Build Date: 2003  
Hull Number: 5025  
SSR: Not found  
CRT No: 112125  
Use: Coastal Cruising.

On: Thursday 7<sup>th</sup> November 2019 starting at 10.00am and finishing at 1.00pm

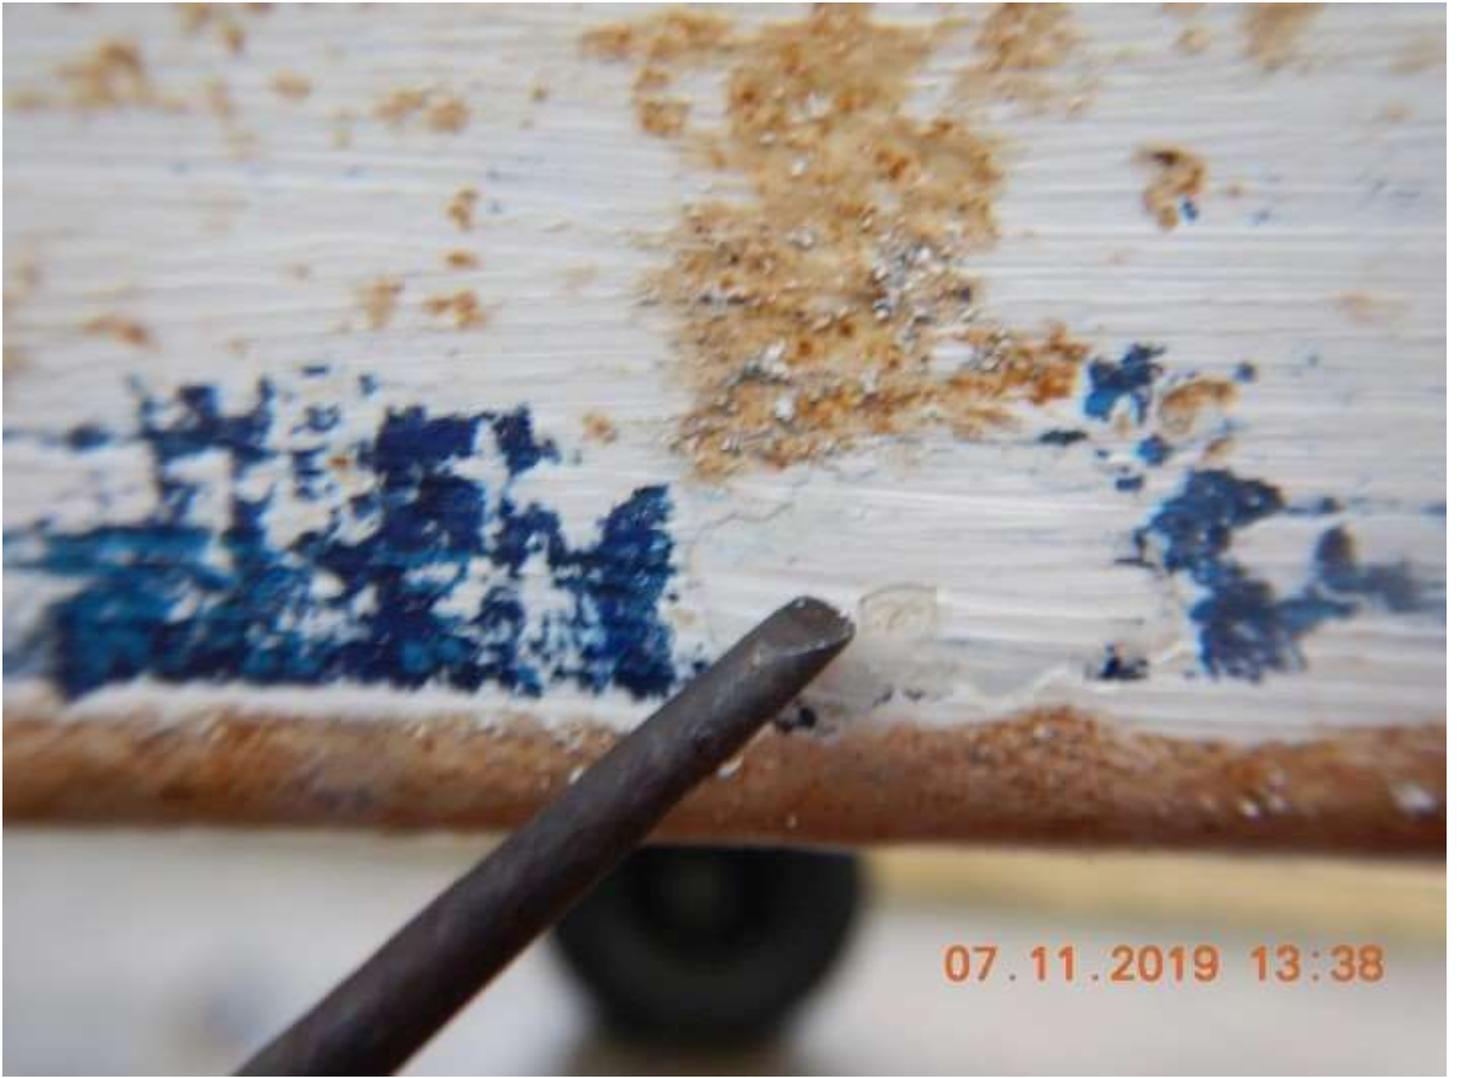
On scraping the hull there was no evidence of osmotic blisters over the main hull, which can be considered very good in a vessel of this age. Three osmotic blisters were found along the port chine which were not considered to be serious.

These should be ground out and filled with epoxy filler. One of these blisters was found again on this survey and the blister had re formed. The pungent liquid associated with osmosis escaped when the blister was burst.

***Suggest: A small osmotic blister found on the port chine. When burst the pungent liquid associated with osmosis could be seen escaping. The 3 blisters found were not believed to be indicative of osmosis forming across the entire underbody. Osmosis is unusual in this type of boat, however with high moisture content this can not be completely ruled out. On the last survey, in other scraped areas the gel coat was found to be smooth with no evidence of blistering. At a convenient time grind out and epoxy fill the few osmotic blisters found on the port chine.***

**Suggest:** *A small osmotic blister found on the port chine. When burst the pungent liquid associated with osmosis could be seen escaping. The 3 blisters found were not believed to be indicative of osmosis forming across the entire underbody. Osmosis is unusual in this type of boat, however with high moisture content this can not be completely ruled out. On the last survey, in other scraped areas the gel coat was found to be smooth with no evidence of blistering. At a convenient time grind out and epoxy fill the few osmotic blisters found on the port chine.*

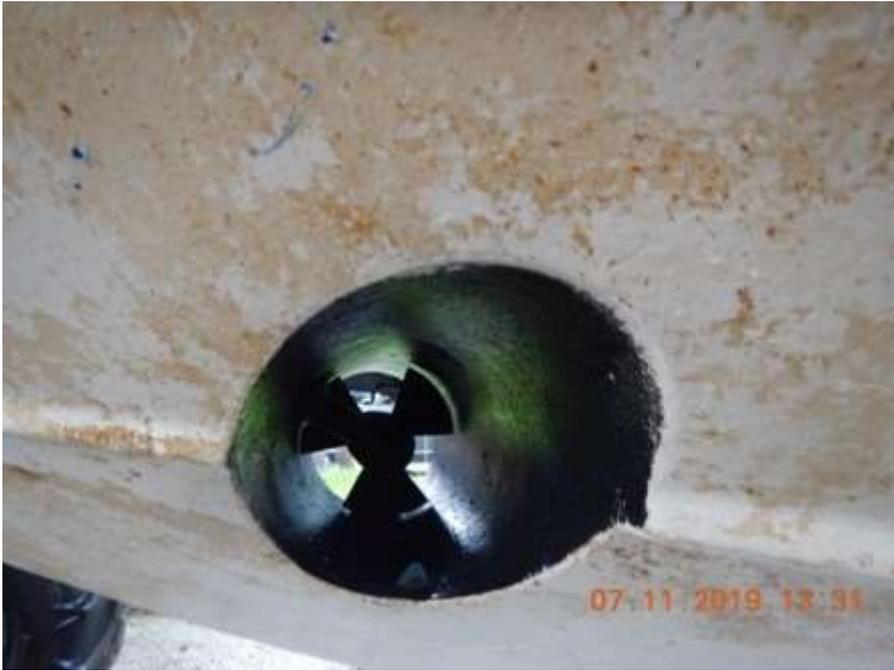
**Bow thruster tube with no debris guards fitted.**

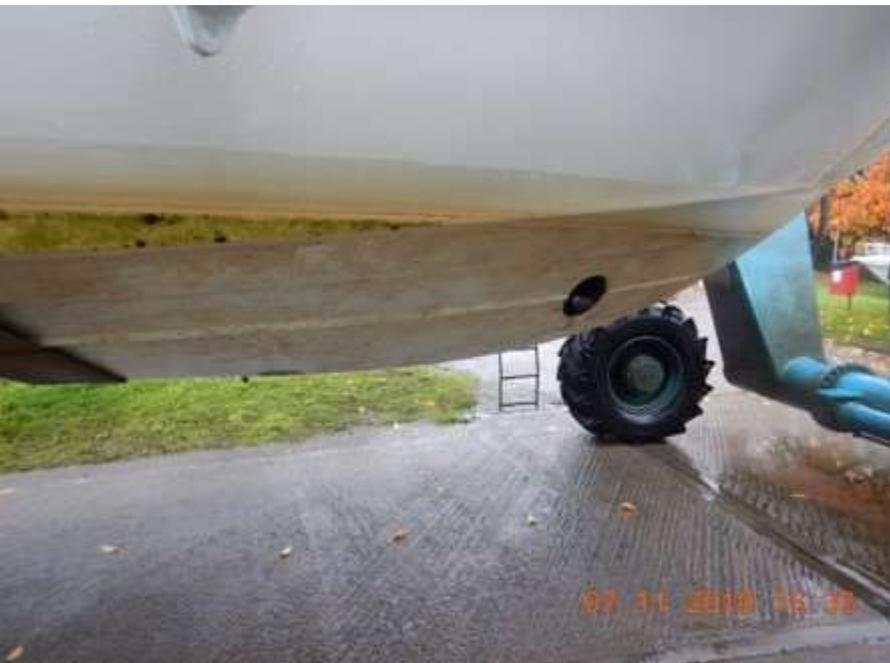
**Bow section showing stringers.**

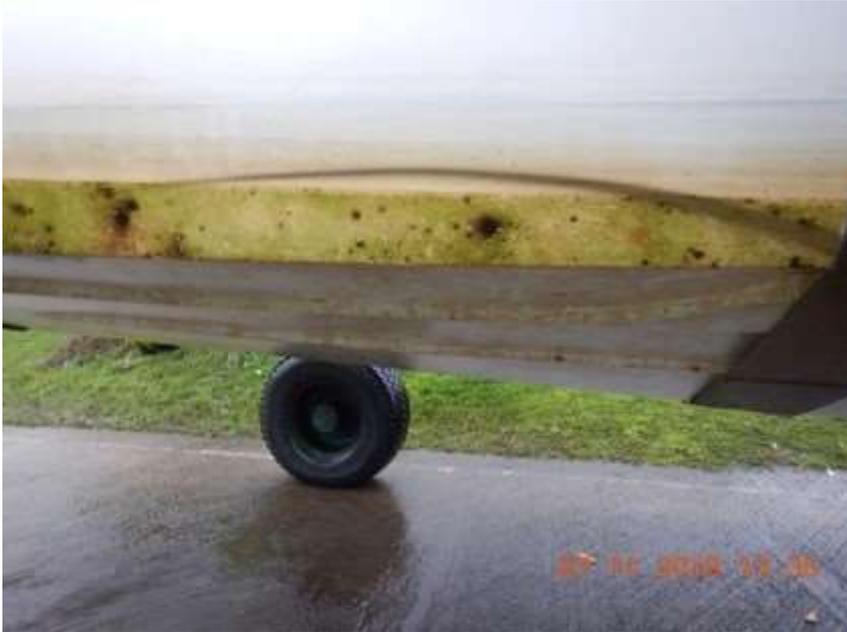
**Mid section showing plane inducer section.**

**The black marks were just growth.**

The underbody was just dirty and most of the markings would come off under pressure cleaning.

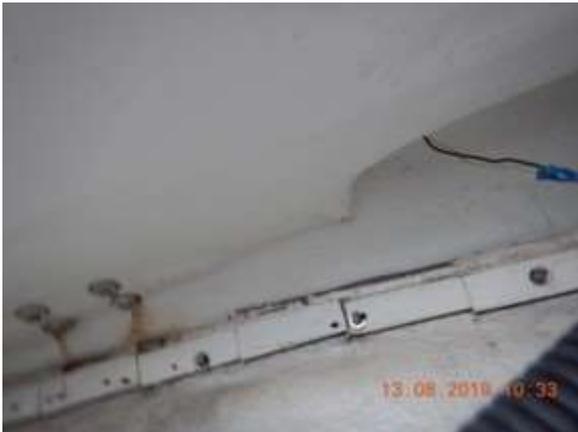
Externally the hull deck joint was covered by a bolted on stainless steel strip found in good condition and secure. Viewing the hull deck joint in the anchor locker it was noted that a number of backing pads had been added internally all the way round the anchor locker. No reason for this could be determined but it was not believed to be original construction.

**Backing pads for through deck bolts and nuts.  
Seepage can be seen through the stanchion bolts above the hull deck joint.**

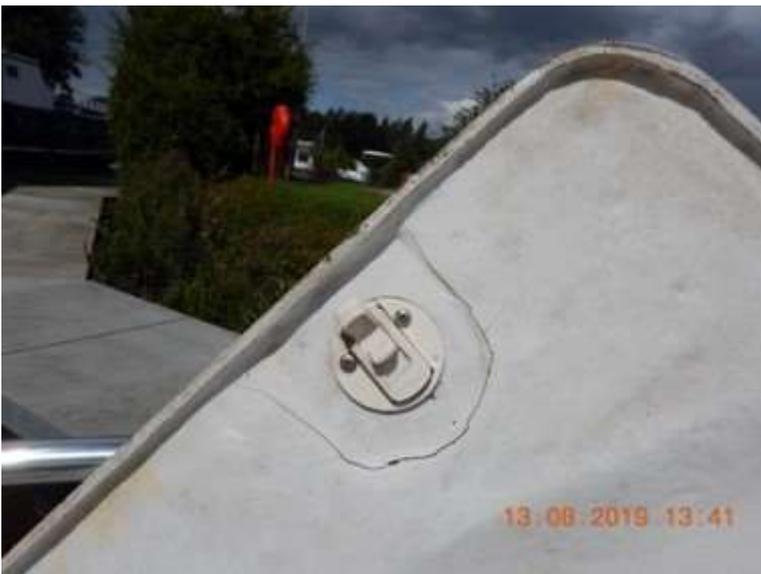
The anchor locker hatch was damaged around the catch.

**Suggest: Repair the crack around the anchor locker catch.**

**Suggest:** *Repair the crack around the anchor locker catch.*

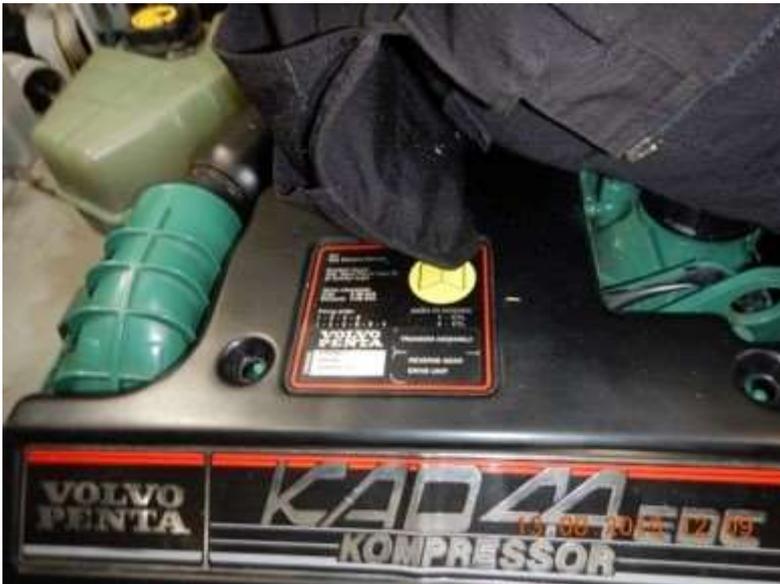
**Suggest: We were advised the vessel had undergone considerable engine maintenance prior to the last survey and Farndon Marina have details of this.**

To avoid confusion the engine was a Volvo Penta  
KAD44EDC

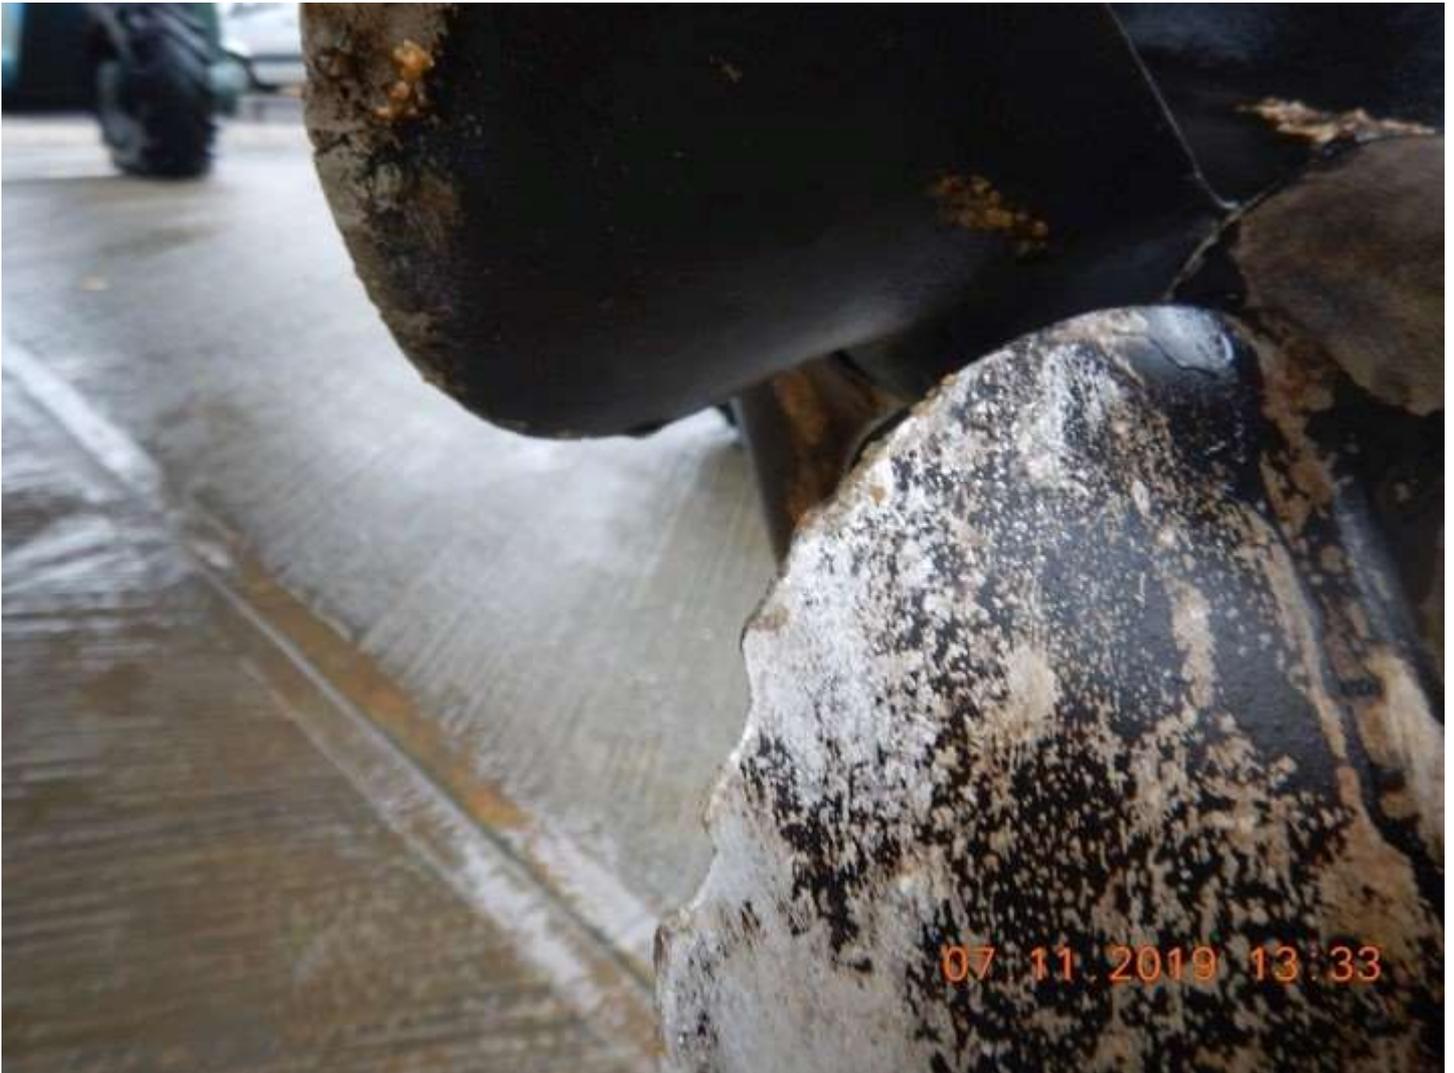
The twin directional duo propeller was securely locked to the shaft . The bearings ran smoothly. The propeller has suffered some impact tip damage.

Hammer testing showed no significant corrosion to the propellers or the outdrive casing. The fin remained in good condition. The paintwork on the casing was found an adequate condition. There was a suitable gap between the outdrive and the antifouling. The anodes on the outdrive have all been replaced since the last survey.

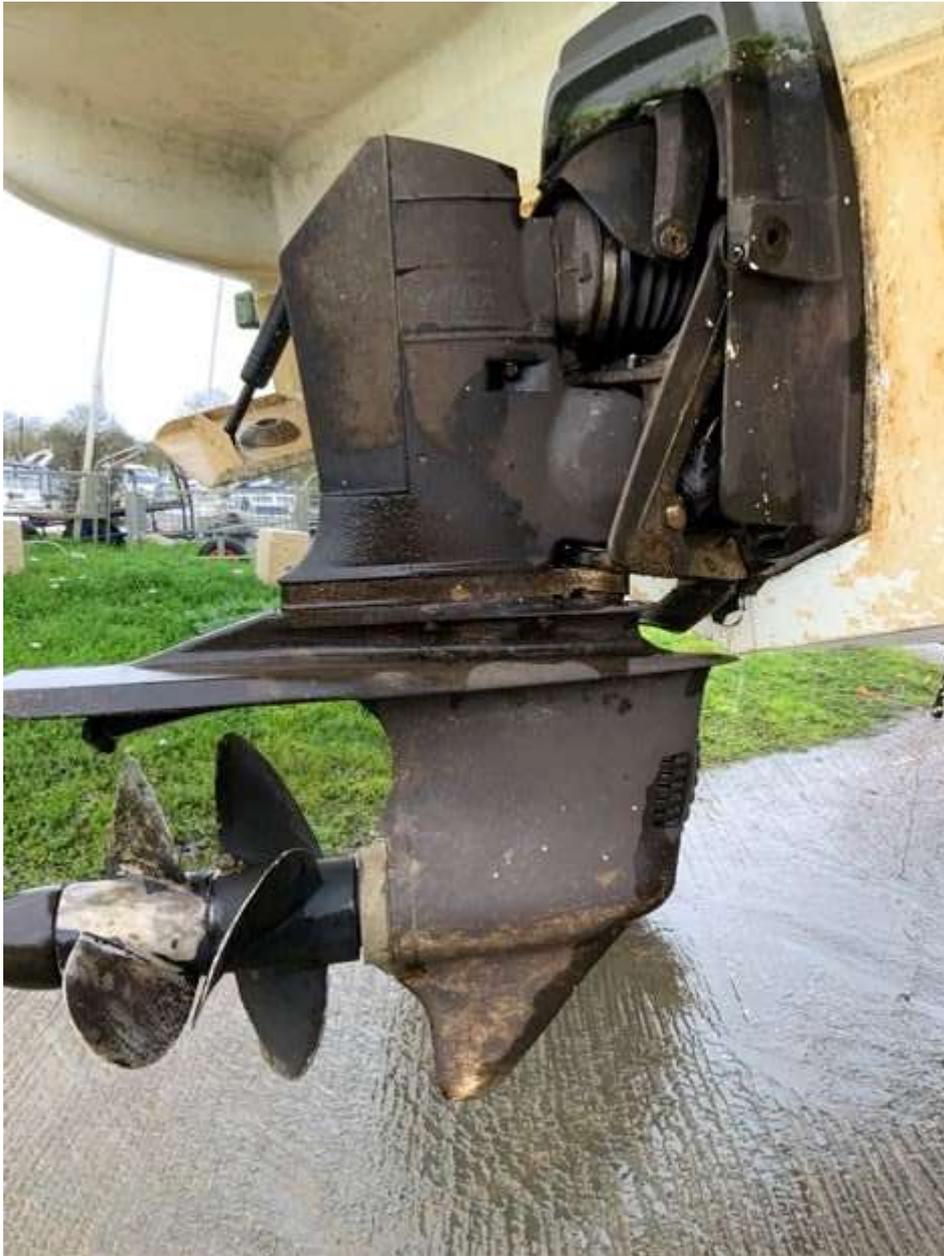
**Condition of stern drive bellows.**
