Mike Chadwick Surveys Ltd.

Boat Inspection Report:

Report No: 100010

Make: Narrowboat
Type: Traditional stern
Advised Build Date: 1990
Builder: Les Allen and Sons
Canal and River Trust No.
HIN Number: Not applicable
Use: Inland Waterways Cat D

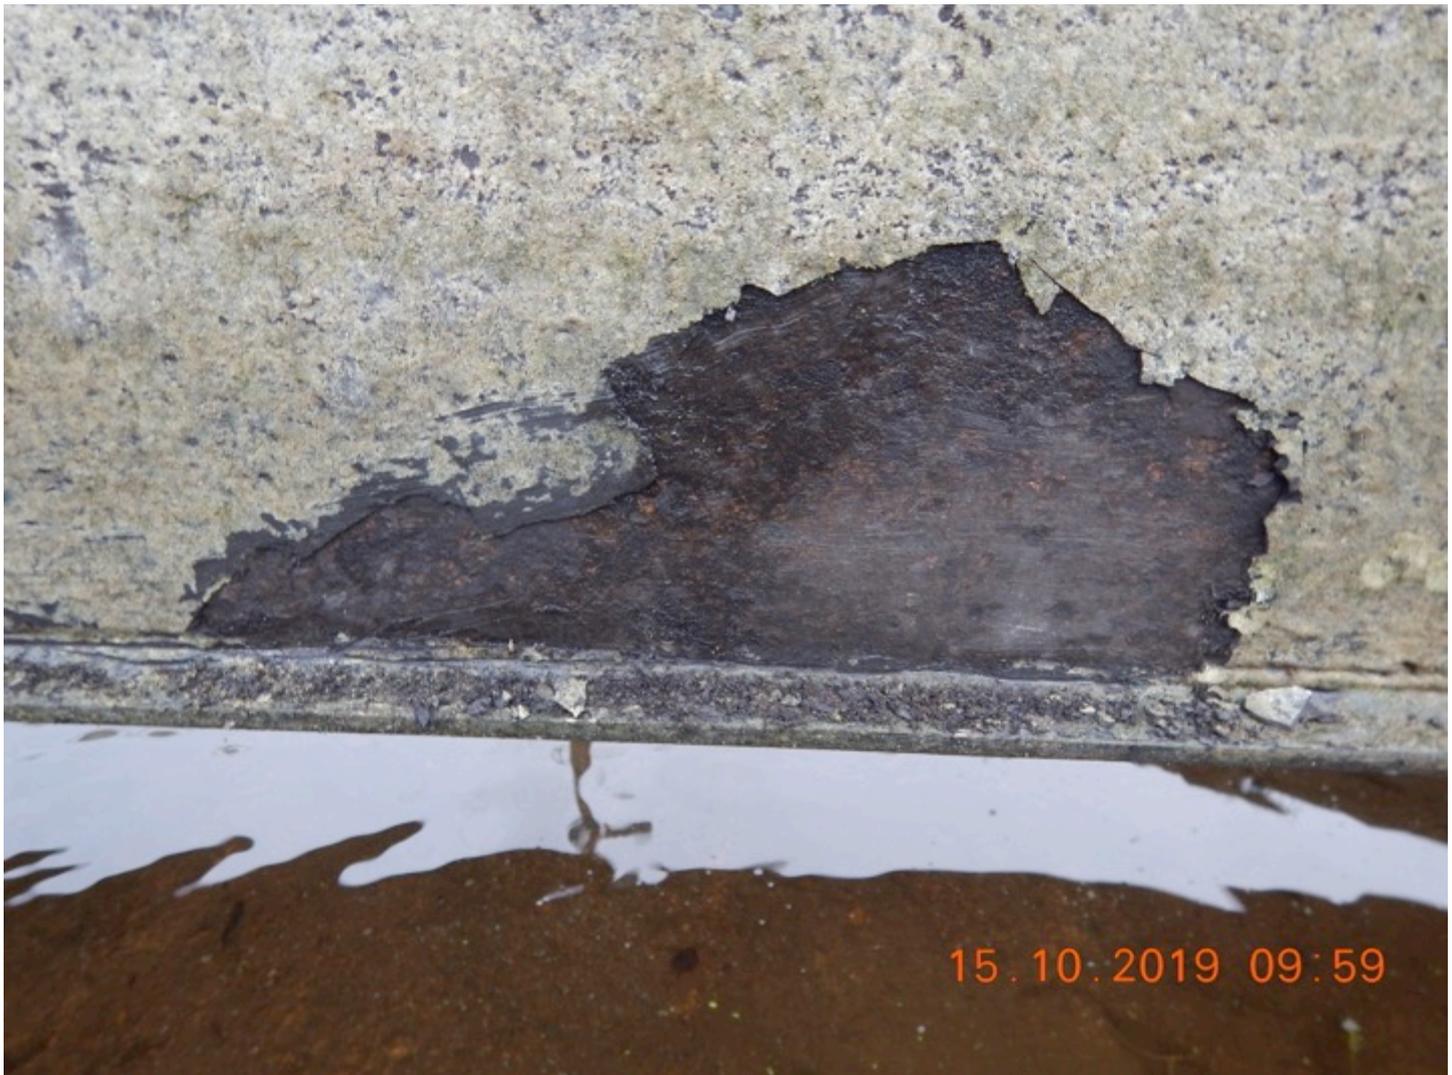
The side plates above the water line were clean and fair. The paintwork above the waterline was in fair condition. There was rust corrosion along the waterline. Waterline corrosion was not considered serious at this time but should be cleaned off and re painted. There was no visible evidence of significant impact damage or indentation. The side plates were coated in a very thick layer of bitumen blacking which hindered inspection. In places this thick blacking chipped off under aggressive hammer testing. One section midships to starboard was cleared of all blacking to inspect the steel below with very little pitting or corrosion found.

The welding to the hull was a little uneven but believed to be serviceable. Welded butt joints were externally inspected, were tidy and unobtrusive and hammer tested serviceable. Waterline pitting was minimal. Aggressive hammer testing below the waterline produced no evidence of weakness in the steelwork. Sample hammer testing carried out around welds gave no indication of weakness. The rubbing bars were welded top and bottom, which was considered good practice.

Suggest: The use of two-part epoxy paint protection for side shells and base plates is becoming more common on narrowboats for long-term protection. This is the best defence against future corrosion. This is more important if shore power and a 230v battery charger are to be used regularly.

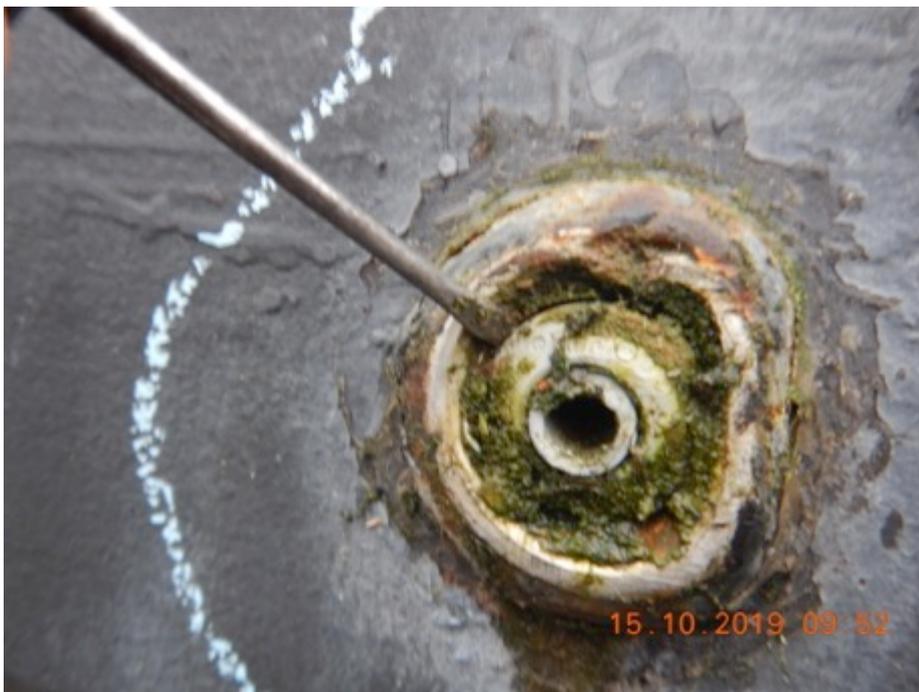
Most overboard drains were above the Canal Boat Association recommendation of a minimum 250mm freeboard. The kitchen sink discharge was in very poor condition and was seen to have a smaller discharge set in to the normal 2" discharge and secured with silicone. This is not safe practice and the discharge should be replaced by one that fits the hull securely.

Unsafe sink overboard discharge.

Recommend: Replace the sink drain overboard discharge skin fitting. Any discharge pipes connected to skin fittings, below the industry standard 250mm above the laden waterline should be securely clipped at both ends and loop up to deck level where possible. All hull fittings should be secure and sealed. All open holes in the side shell should be welded up securely in case the vessel tips on the bank or in floods. Any redundant discharges should be welded up permanently.

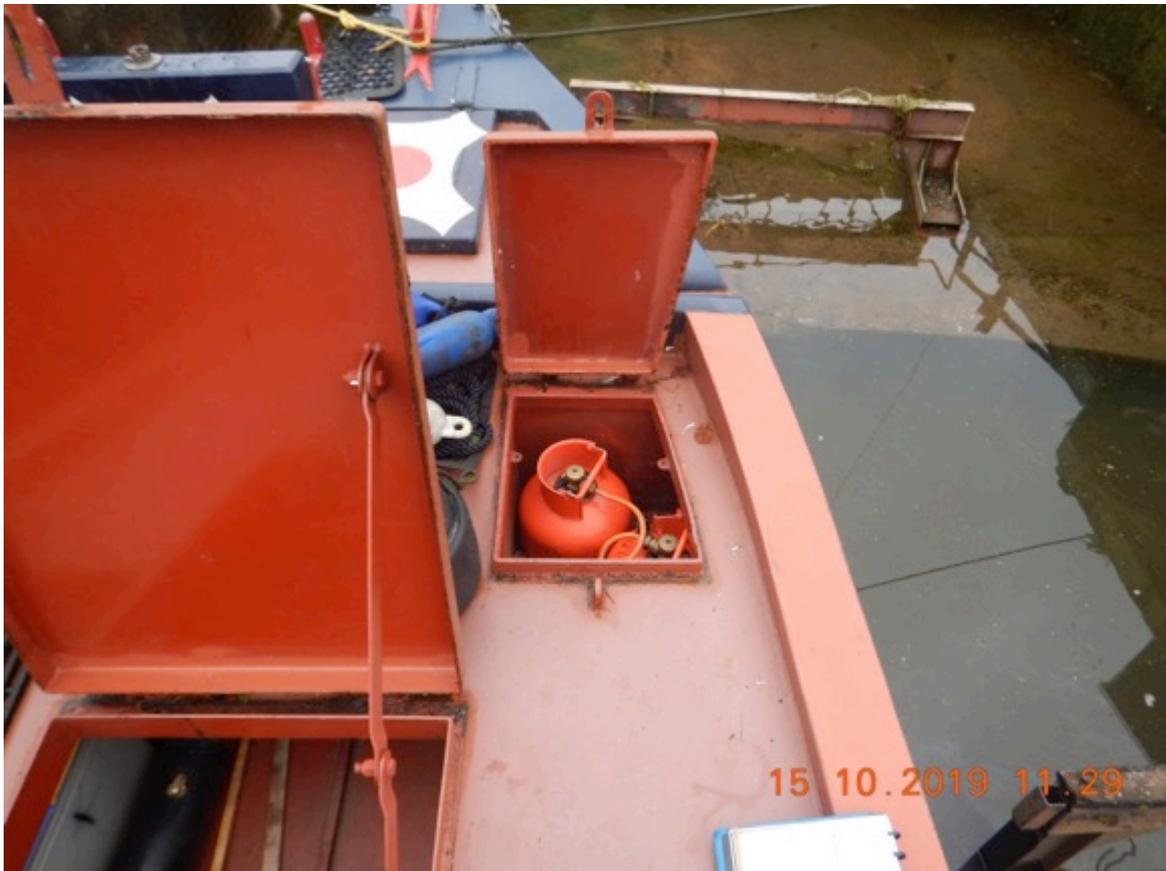
The "Tug" deck was generally in serviceable condition with four heavy lift up hatches to allow for gas lockers and storage. The hatches to these lockers were of good quality and with high lips to stop water ingress.

Recommend: Add a non slip finish to the side decks and steering deck.

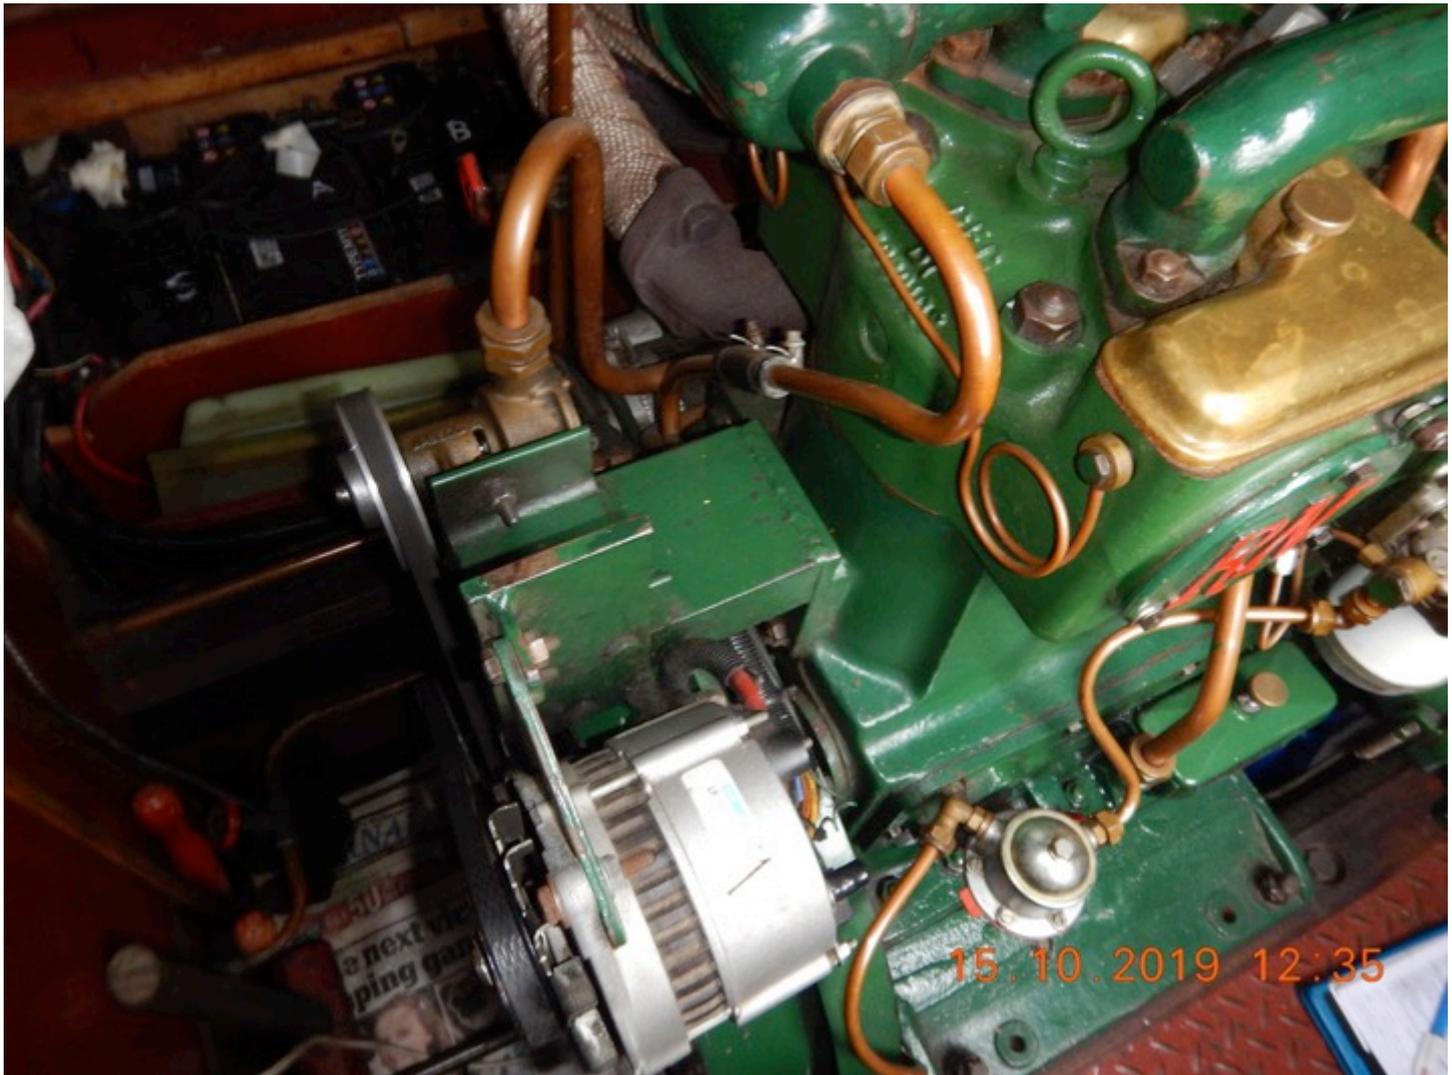
The engine bay was dry and well painted. There was dry newspaper under the engine with no evidence of oil leaks in the drip tray.
