## Boat Inspection Report

Report No: 1001

Make: Maxum  
Type: 2700 SE  
Advised Build Date: 2003  
Hull Number: 5025  
SSR: Not found  
CRT No: 112125  
Use: Coastal Cruising.

On: Thursday 7<sup>th</sup> November 2019 starting at 10.00am and finishing at 1.00pm

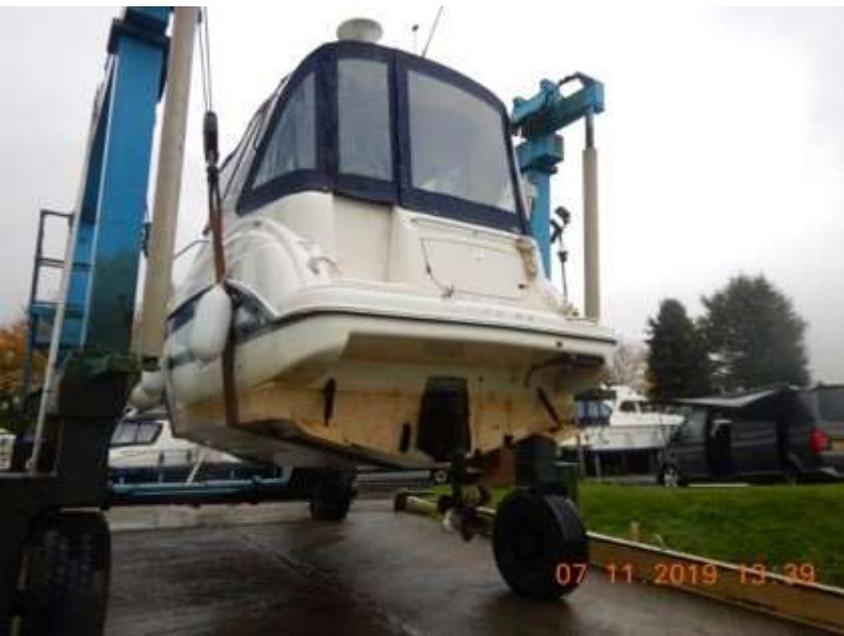
**The black marks were just growth.**

The underbody was just dirty and most of the markings would come off under pressure cleaning.
